MARINE INVESTIGATION REPORT
M01C0008

STRIKING OF THE TANKER *HAMILTON ENERGY*
AND
STRIKING AND SINKING
OF THE TANKER *PROVMAR TERMINAL*

BY THE BULK CARGO *UTVIKEN*
NEAR PIER 23, HAMILTON HARBOUR, ONTARIO
01 APRIL 2001

Report Number M01C0008

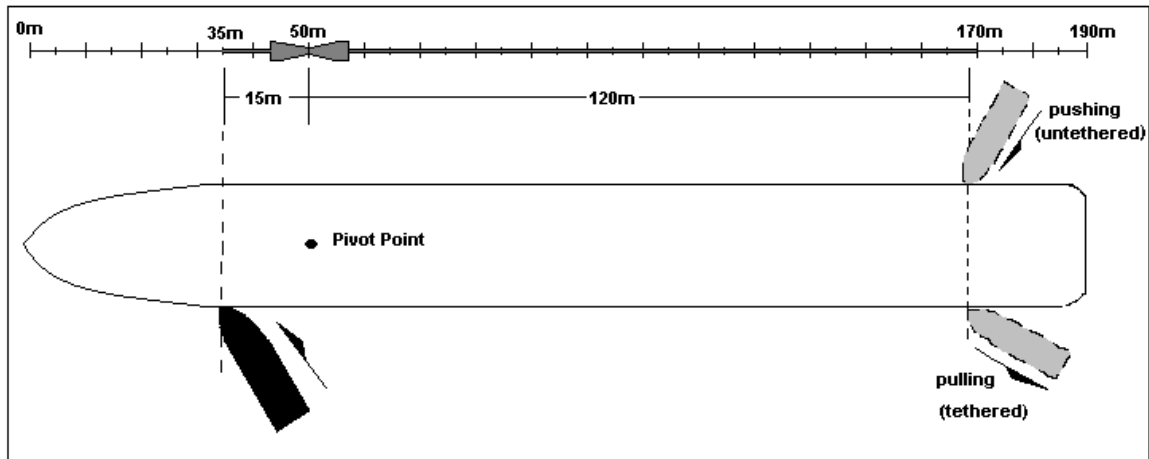
In this occurrence, the unsecured tug was pushing just aft of the break of the forecastle, or approximately 35 m from forward. Because the *Utviken* was making headway, the pivot point of the vessel would have been approximately 50 m from the bow, giving a turning lever of some 15 m for the forward tug. The aft tug would have had a turning lever in the order of 120 m. Even considering the relative difference in tug power (1100 hp forward versus 700 hp aft), the aft tug pulling on the port side, if made fast or pushing on the starboard side, would have produced about five times the turning moment of the forward tug (see Figure 2). Additionally, once the anchors were let go, the pivot point would have moved even further forward, to a point between the two windlasses. The forward tug's ability to effect a starboard turning moment at this time would have been minimal.

Figure 2. Pivot point, turning levers and moments

In the last minutes before the striking, the aft tug was not used in a manner most effective in turning the vessel to starboard. For the forward tug, the reduced turning lever, the angle of application of the pushing force, and the deployment of the assisted vessel's port anchor all decreased the effectiveness of turning the vessel to starboard. Although the instructions for the forward tug to push full on the port bow were taken in good faith and with the best of intentions, the starboard turning moment applied on the *Utviken* by this action was minimal. Also, contrary to the wishes of all concerned, the assisted vessel's speed reduction was hampered by the forward component of the pushing forces applied by the *Paul E No. 1*.

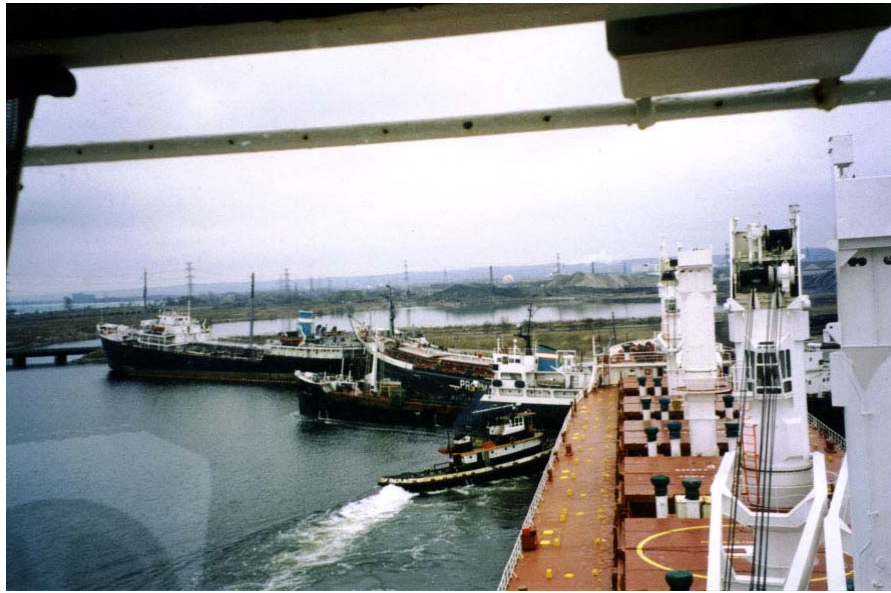
At 1340 to 1341, on a heading of approximately 170°(T), the *Utviken's* bulbous bow struck the port quarter of the *Hamilton Energy*, approximately 4 m below the surface of the water in way of the skeg, propeller and rudder. The *Hamilton Energy* was instantly heeled over to port (60 to 70 degrees), submerging the main deck port railing.

Photo 1. Striking of *Hamilton Energy*
Note: Wakes of *Hamilton Energy* and tug *Paul E No. 1*

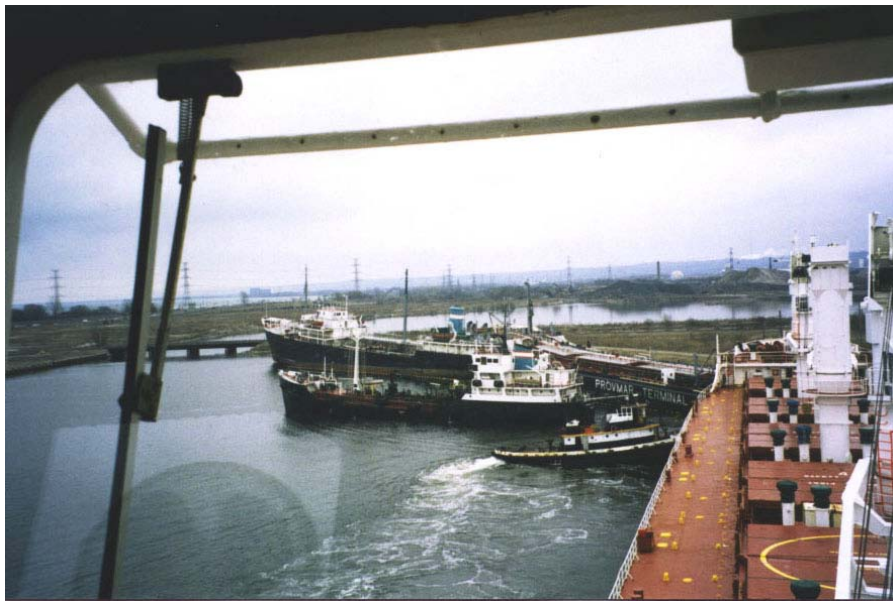
While still moving forward and to starboard, the bulbous bow of the *Utviken* then penetrated the engine room spaces of the *Provmar Terminal*, quickly sinking the stern of the vessel in a depth of approximately 10.5 m. The chief engineer, who had been below in the engine room of the *Provmar Terminal*, had just come on deck and was able to safely evacuate the vessel.

The *Provmar Terminal* also suffered heavy damage. Penetration by the bulbous bow of *Utviken* created a 4.0 m by 4.7 m opening into the engine room spaces below the waterline. The subsequent flooding damaged boilers, generators and other electrical equipment.

Photo 2. Striking of *Provmar Terminal*
Note : *Hamilton Energy* adrift
